New Mexico Mining Minerals Division
Abandoned Mine Land Program
Uranium Mine Reconnaissance Files

RECONNAISSANCE REPORT XEROX COPY FORM
ABANDONED MINE LAND PROGRAM
New Mexico Mining And Minerals Division

New Mexico Mining Minerals Division
Abandoned Mine Land Program
Uranium Mine BLM Surveys

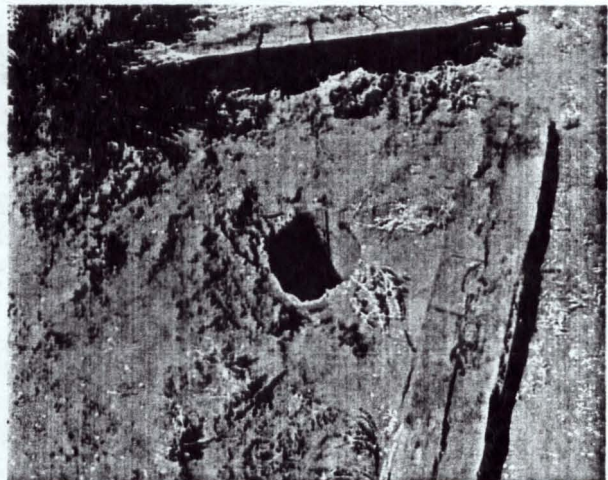
Open vent hole

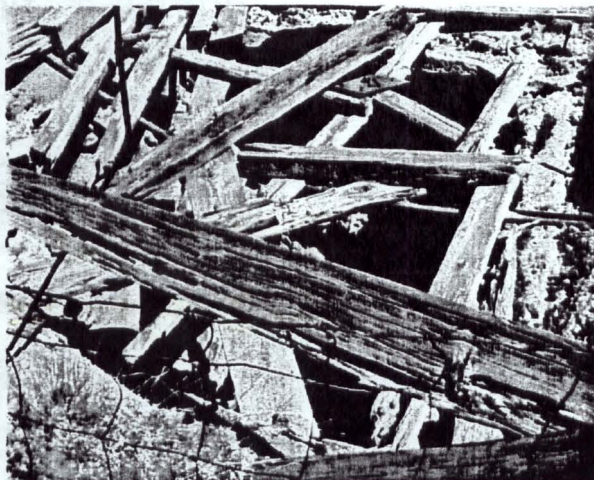
Open shaft

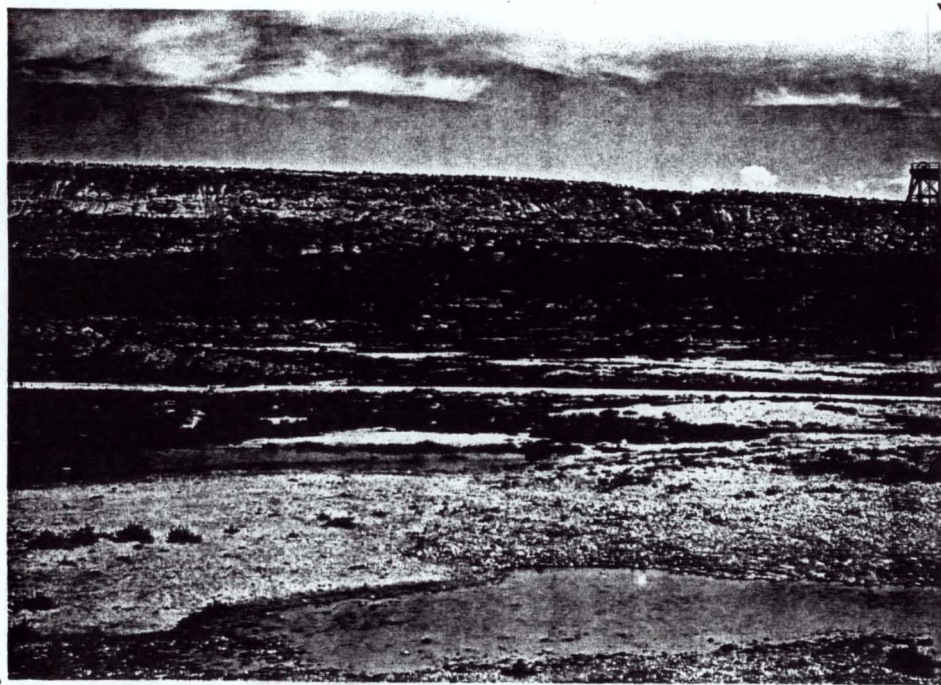
MINE NAME: BARBARA J#2

DESCRIPTION: View of west side of mine. Photo taken
from waste pile of Piedra Trieste and waste in foreground
from that mine.

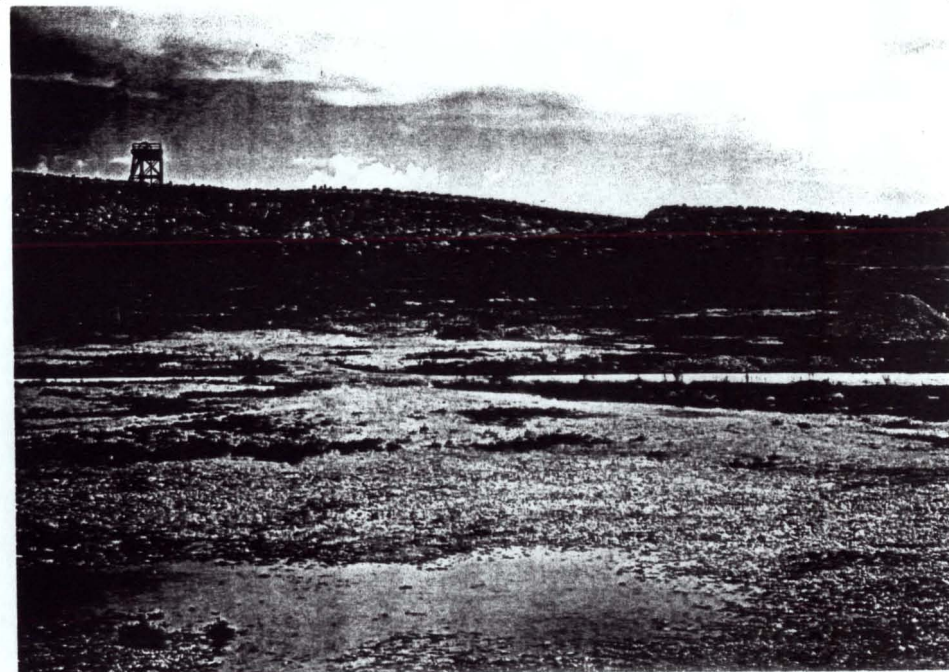
DESCRIPTION: View of east side of mine site. Note
goat herd moving accross mine site.

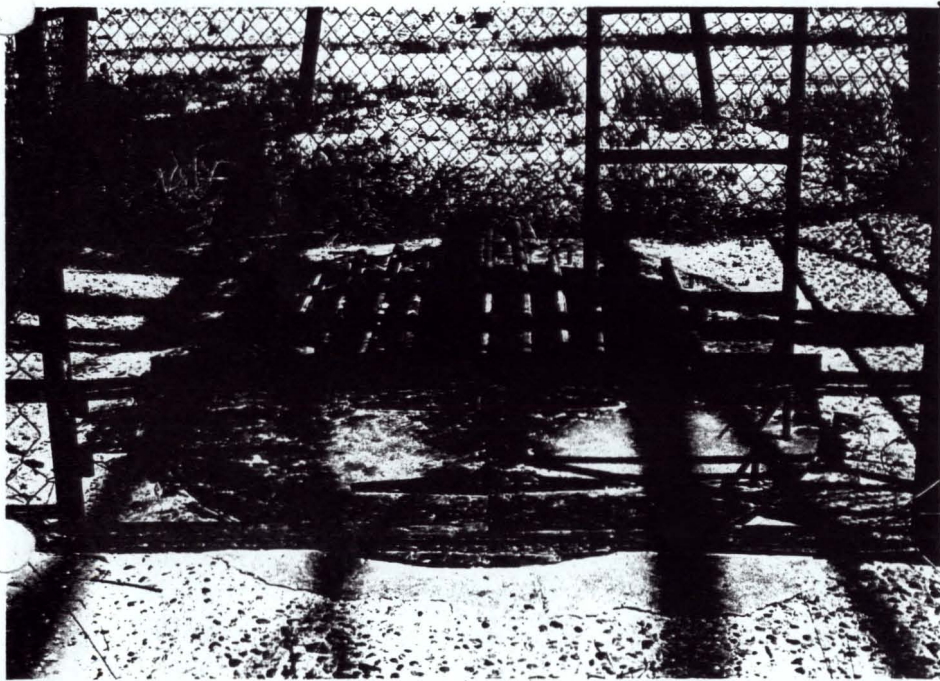
MINE NAME: BARBARA J#2

DESCRIPTION: View of shaft entrance showing measures
taken to restrict access to the mine. Water in shaft
was measured to be 198 feet from the surface. It would
not take much effort to break the weld on the door in
foreground and gain access to the shaft.

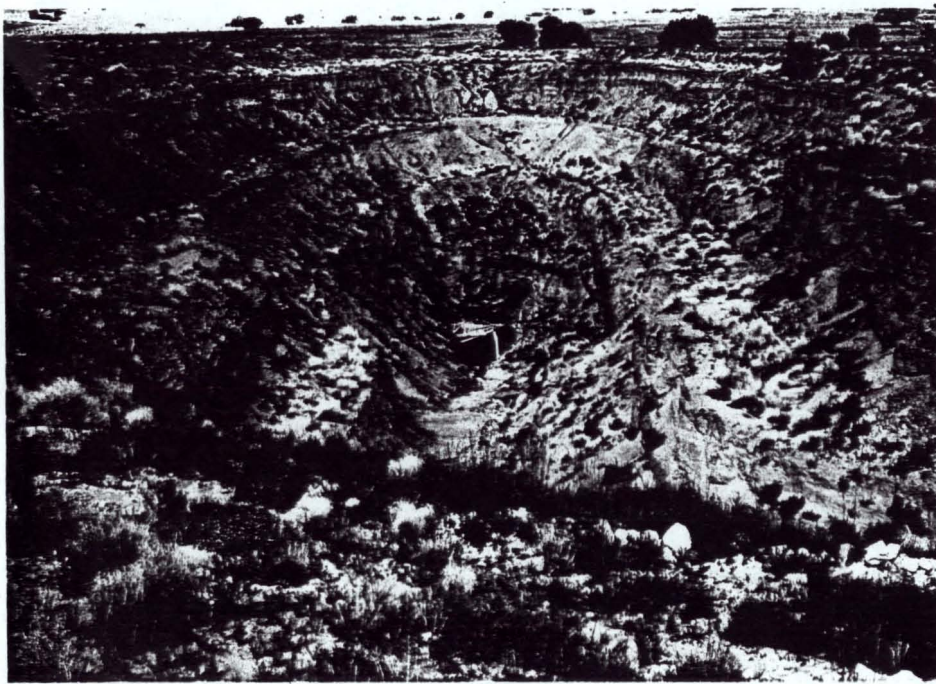
MINE NAME: PIEDRA TRIESTE

CONDITION: Partial cave-in around entrance. Fence intact.

DESCRIPTION: View directly down slope into adit opening.
Adit is open and air coming out of adit gave radiation
reading of 350 uR/hr. Adit has chain link fence across
entrance and has partially collapsed.

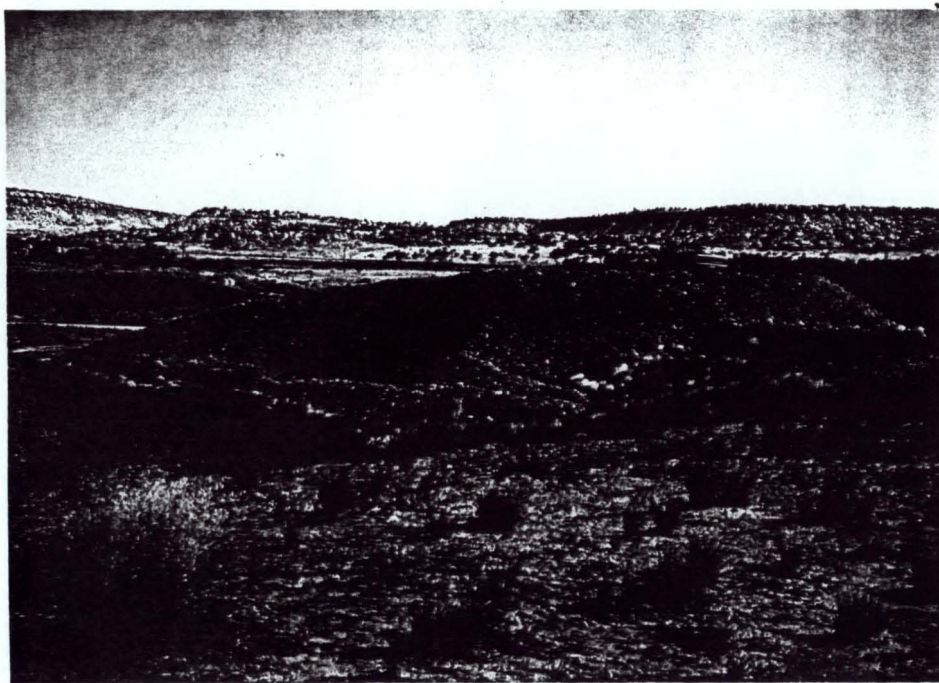
MINE NAME: PIEDRA TRIESTE

DESCRIPTION: View of waste pile on east side of mine.
Note revegetation of soil in foreground and lack of
vegetation on waste pile.

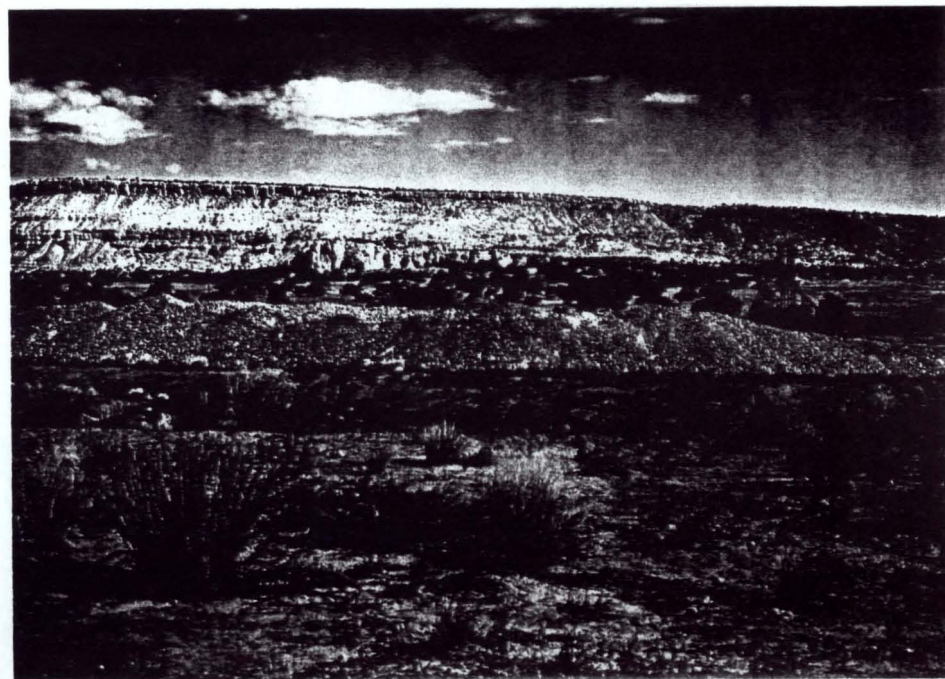
DESCRIPTION: View of western and largest waste pile.
Note headframe of Barbara J#2 mine in right of photo.

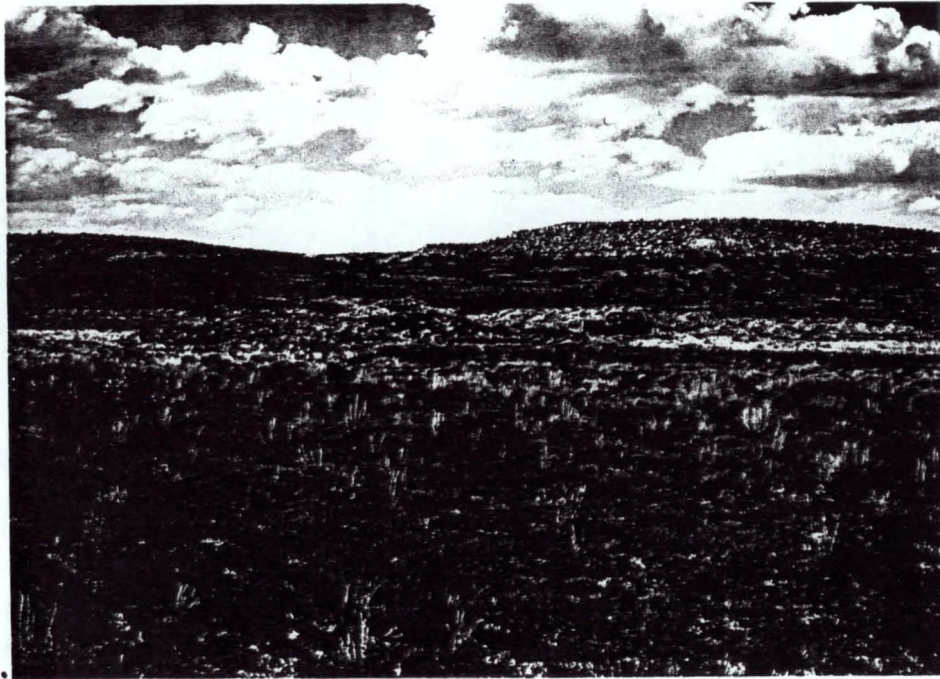
MINE NAME: FLAT TOP MINE

DESCRIPTION: Wide view of mine disturbance. Note
revegetation of site.

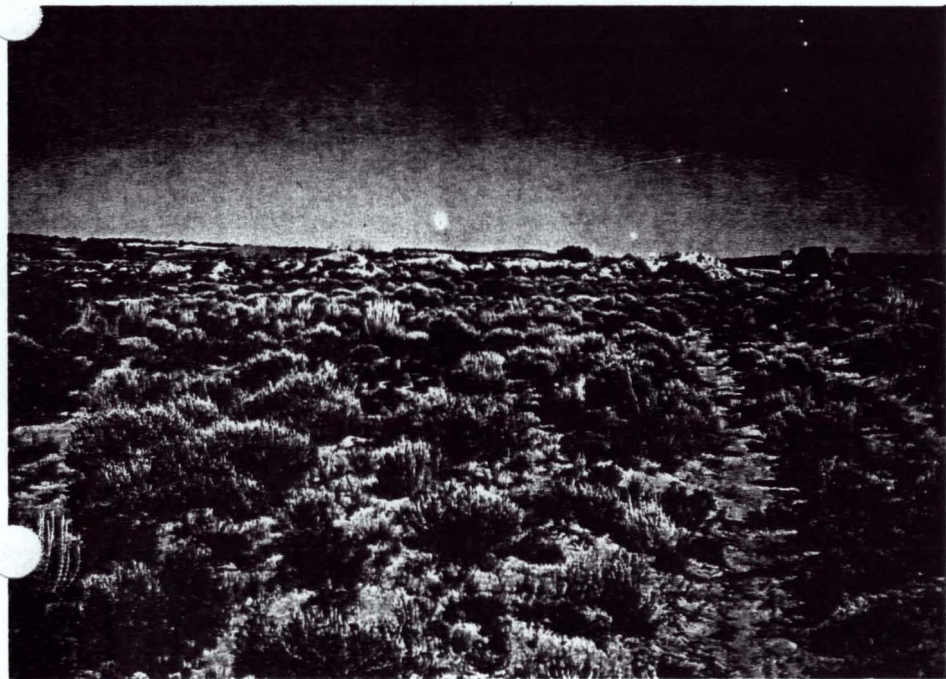
MINE NAME: T-20 SHAFT

DESCRIPTION: View from east showing south portion of
waste piles.

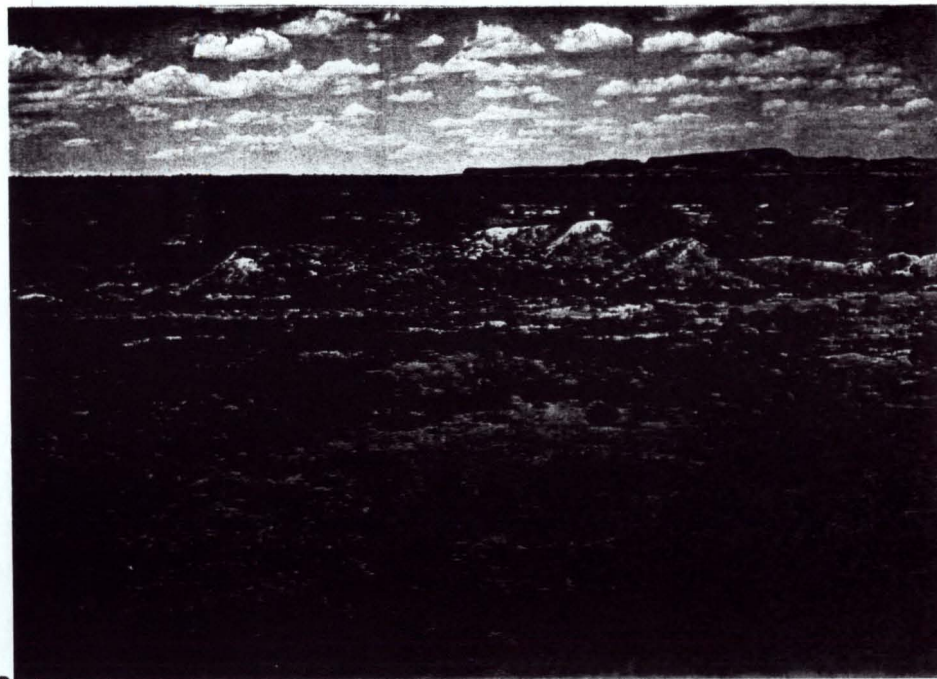
DESCRIPTION: Central portion of mine showing
waste piles and surrounding vegetation.

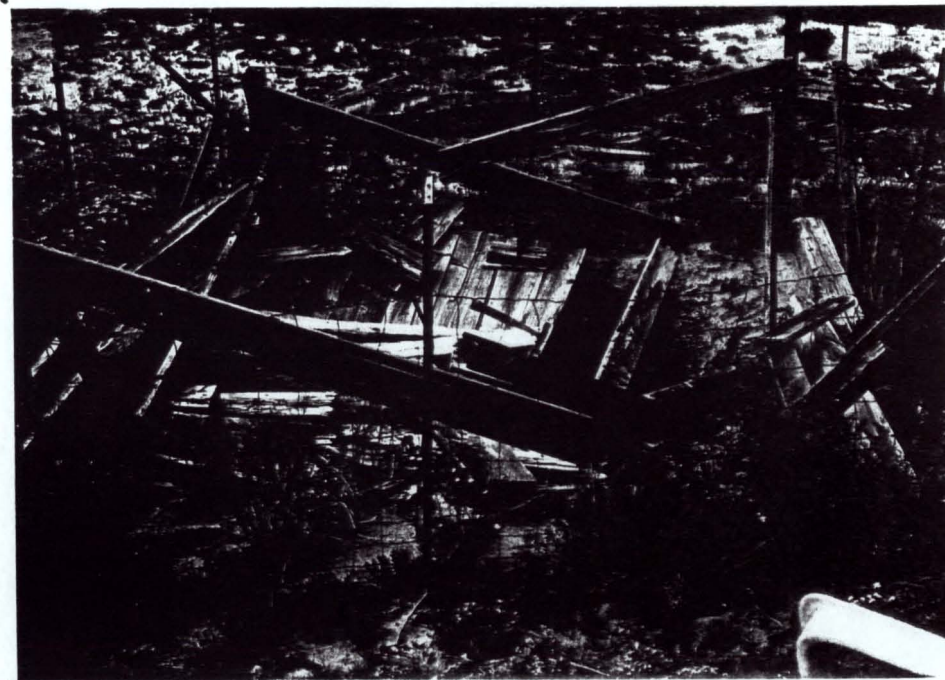
DESCRIPTION: Main shaft at surface approximately
12' x 12' about 40' - 60' deep.

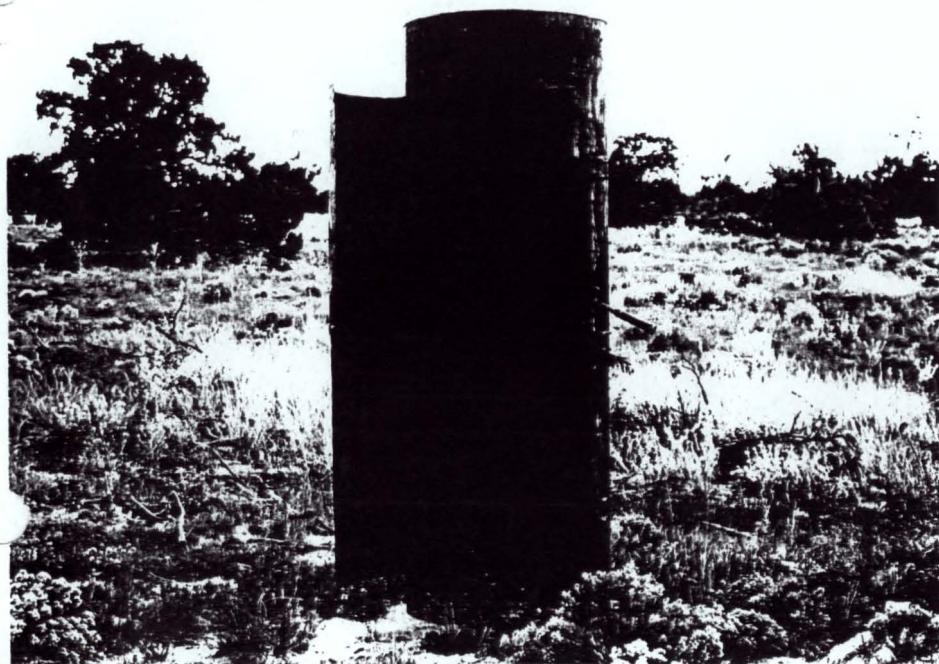
MINE NAME: Mesa Top

DESCRIPTION: Open escapeway.

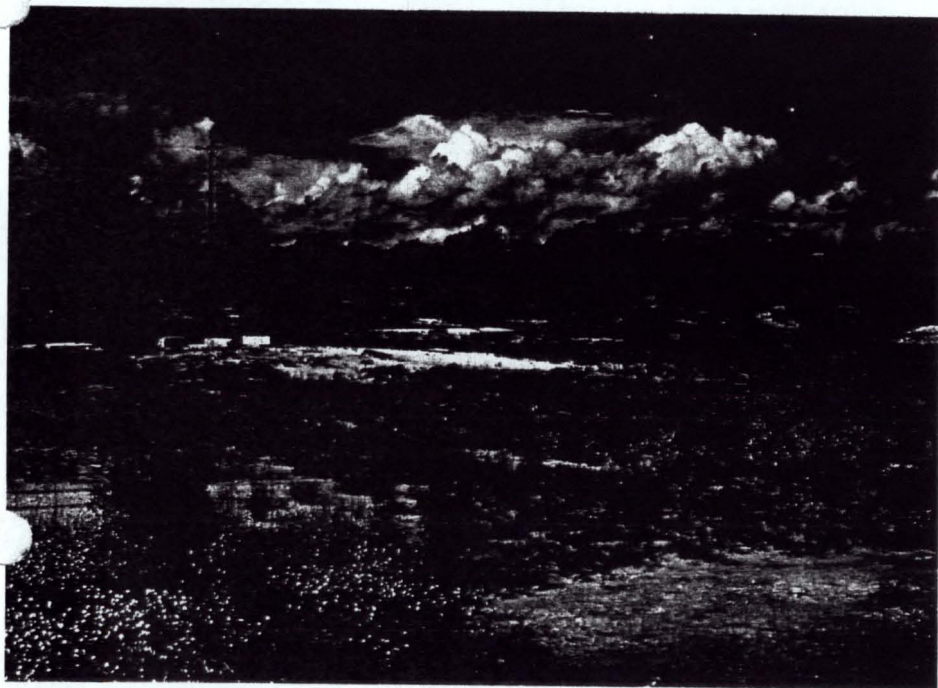
MINE NAME: East Malpais

DESCRIPTION: View of shaft in center of photo and part
of work area and its revegetation.

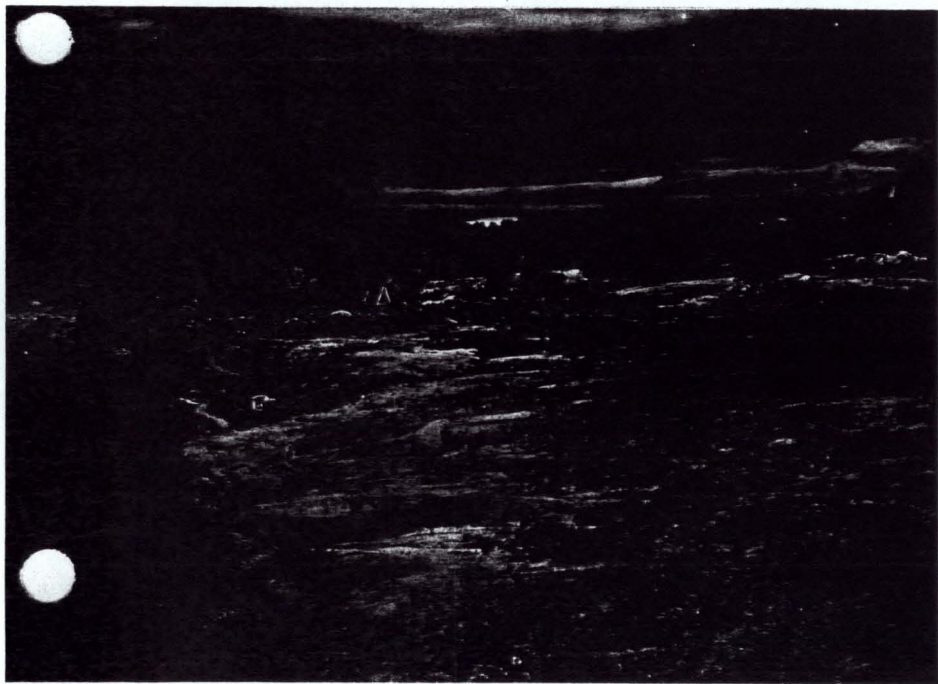
MINE NAME: Dog

DESCRIPTION: General view of mine showing ore car hoist
at the inclined shaft opening. Note waste along arroyo and
the erosion taking place on the waste areas revegetation
occurring slowly.

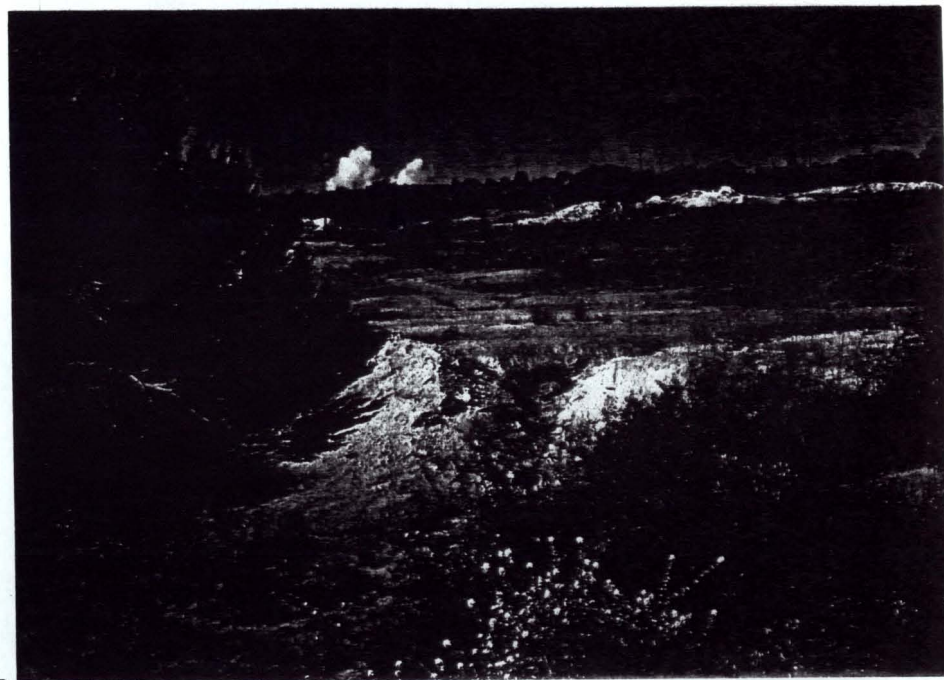
DESCRIPTION: Erosion cutting into radioactive waste
along arroyo

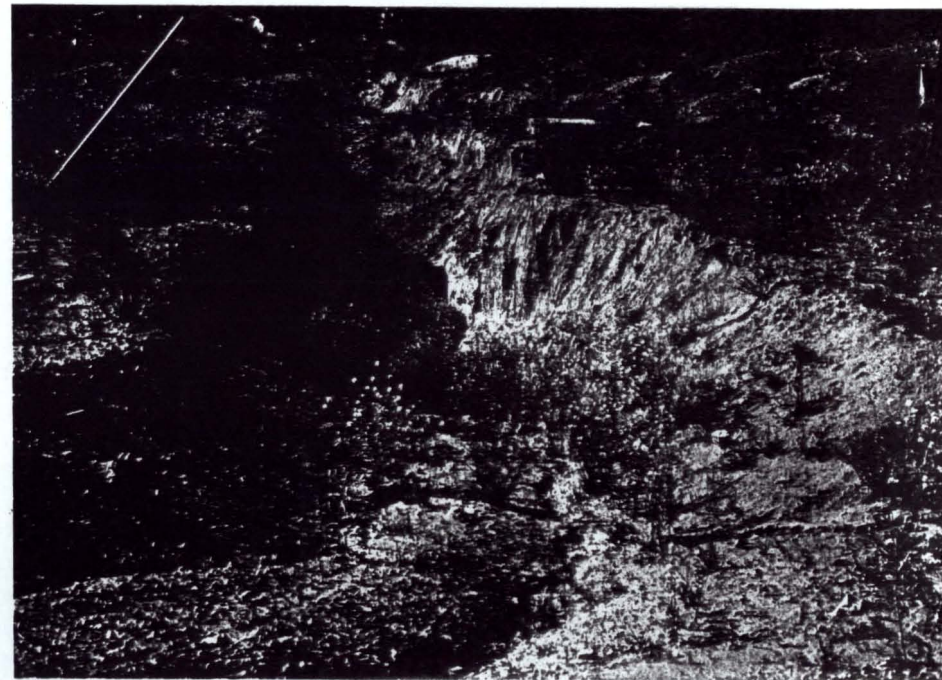
DESCRIPTION: Either collapse area is eroding or
bulldozer cut was made along entrance to open or try to
close it.

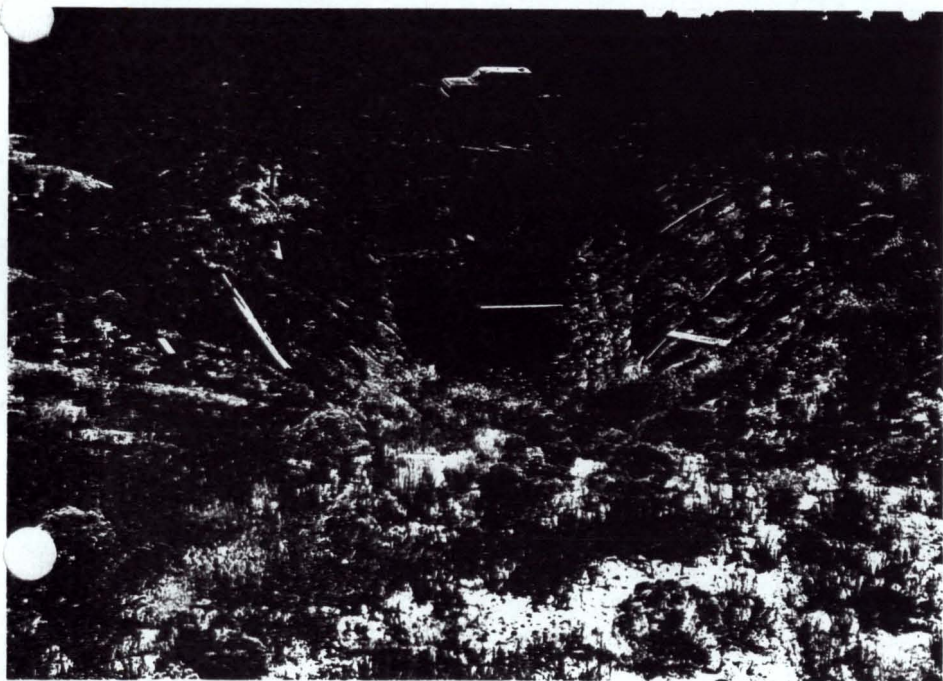
MINE NAME: DAVENPORT INCLINE

DESCRIPTION: View directly down incline. Note erosion
on sides and revegetation of waste pile in foreground.

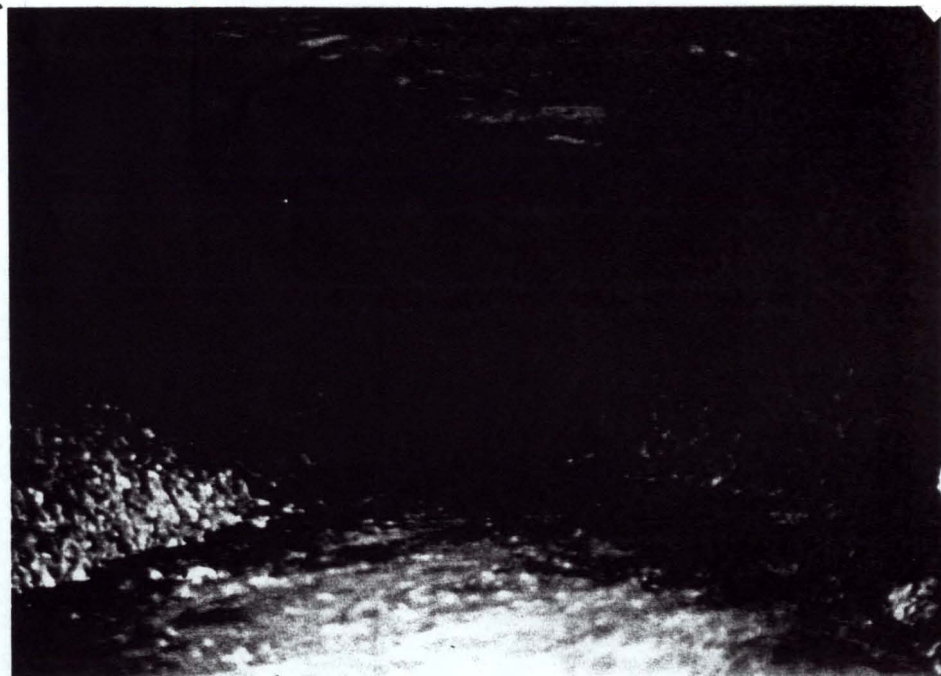
DESCRIPTION: Shot directly into adit opening showing
back of mine. Approximately 60 feet.

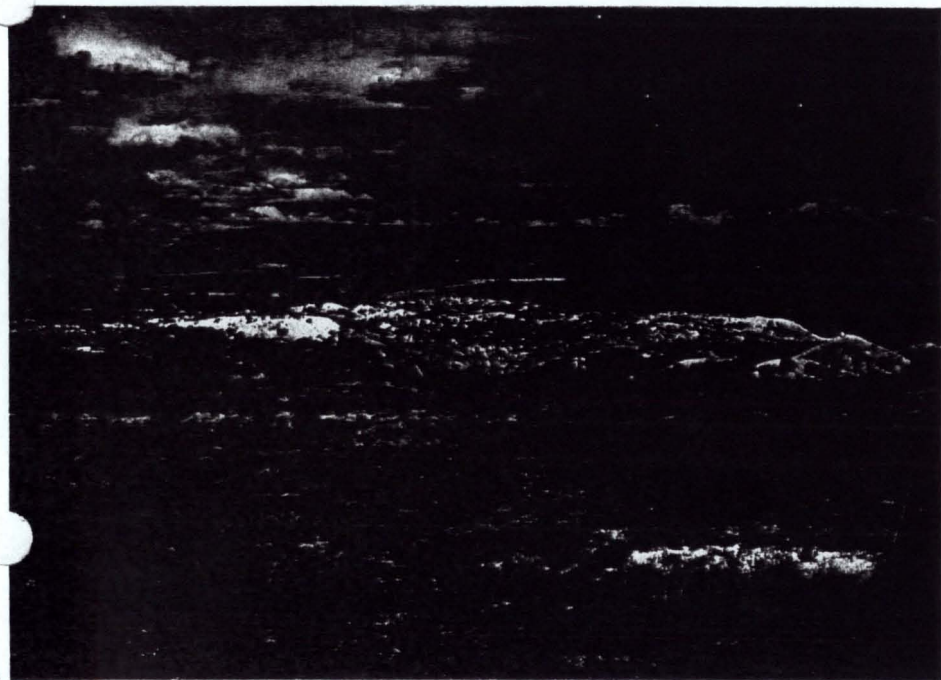
MINE NAME: Davenport Incline

DESCRIPTION: General view of mine area showing
extent of waste. Vehicle is a top of incline, facing north.
